**EXTERIOR BUILDING ENVELOPE INSPECTIONS
USING
THERMAL INFRARED IMAGING**

A REPORT TO THE PUBLIC BUILDING SERVICE OF THE GENERAL SERVICES ADMINISTRATION

Contract Number GS-00P-04-CYD-0068

June 30th, 2006

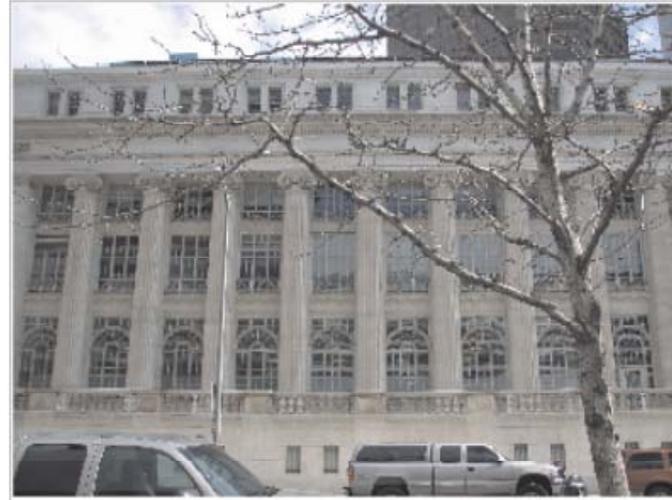
Fig. 4
Byron White - Location 8

Note the warm temperature in the inside corner of the building. This pattern is repeated on all four sides of the building at all outdoor temperatures, suggesting a greater heat loss from these corners than from the balance of the exterior walls.

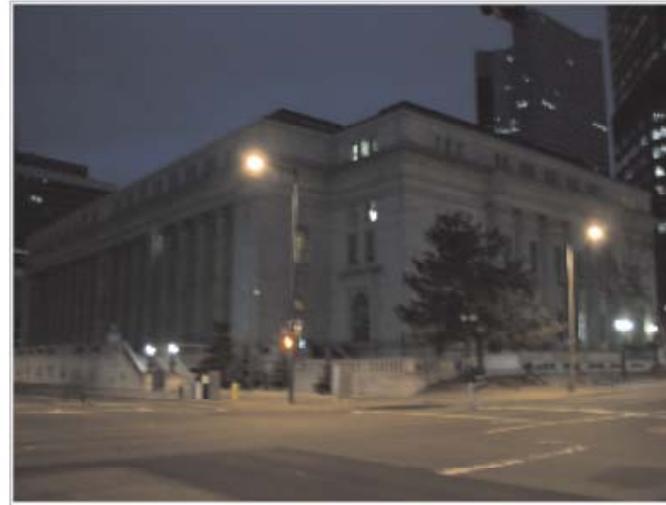
Fig. 6
Byron White - Location 7

Again note the warm temperature in the inside corner of the building, as seen under warmer outdoor conditions in figure 5.

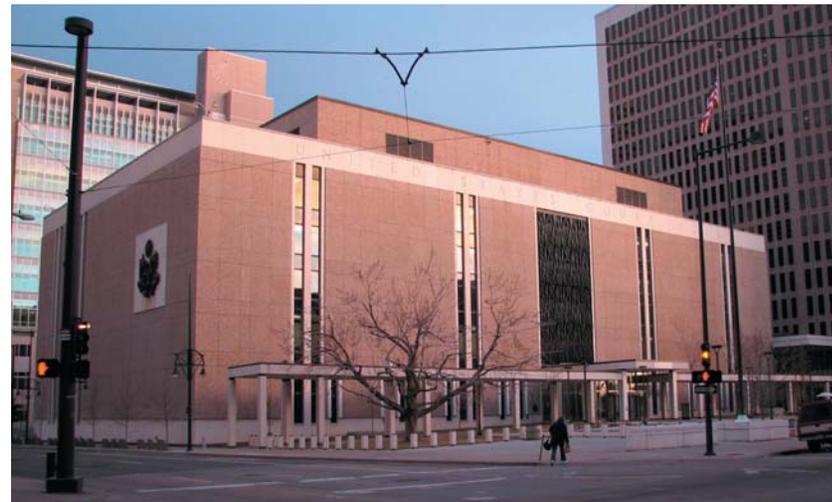
Fig. 9
Byron Rogers - Location 5

The striking thermal pattern seen in this image has no obvious cause, but is certainly not normal.

Heat is leaking at a greater rate from light areas, which are considerably warmer than the balance of the wall. Note that point one, in a warm area, shows a temperature of 37° which is 17 degrees warmer than was typical at that time for the rest of the walls, as indicated by the reading at point 3.

This pattern was not better-understood after imaging under warm weather conditions. Exterior images taken un June 2006 showed faint traces of these patterns. Unfortunately, in spite of excellent interior access, no internal imaging was possible in this spot, because the interior finish consists of wood paneling. The extra layer formed by the interior paneling made it impossible to gather useful information to explain this pattern from indoors.

This pattern remains an unexplained anomaly.

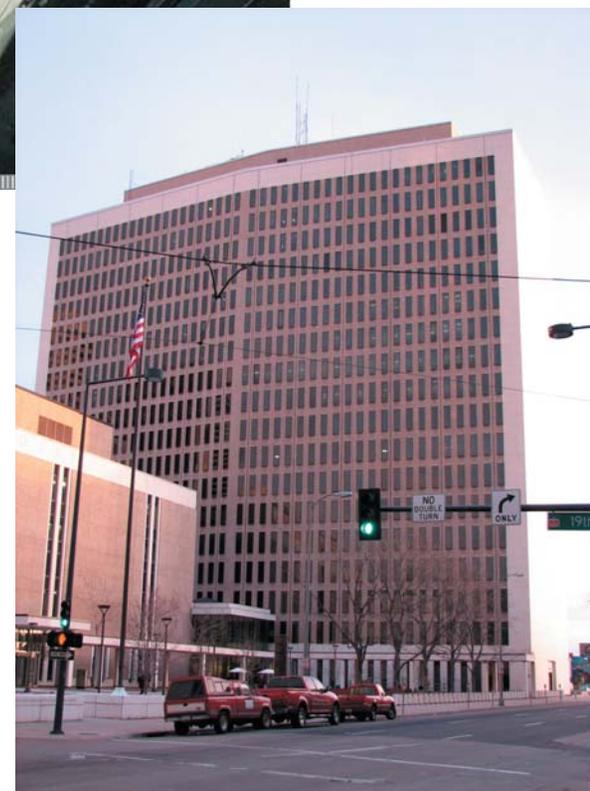
Fig. 17
Federal office building - location 5

The pattern shown here is consistent with air leakage due to the stack effect.

In that phenomenon, warm air rises through the building and leaks out through cracks around windows and at panel joints, showing warm spots on the exterior, just as seen in this image.

The temperature indicated at point 1, in one of the warm spots is 45°F, at a time when the outdoor temperature and the temperature of much of the rest of the walls is 34°F as shown at point 3.

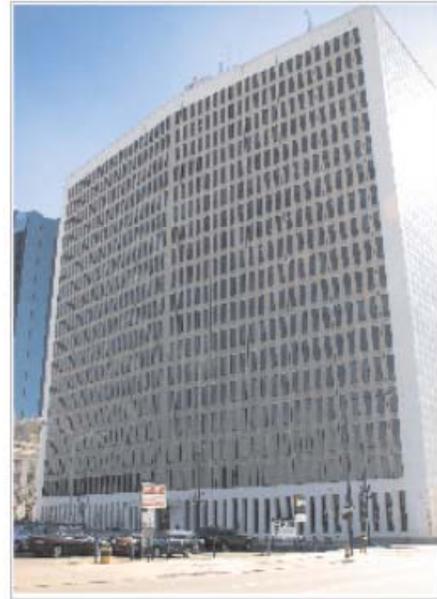
Fig. 19
Federal office building - Location 1
 On the back side of the building, the pattern remains consistent with air leakage due to the stack effect.

In addition to air leakage due to stack effect, on the back side of the building there is a puzzling pattern of warm surface between the 6th and 7th floors, but only at the northern corner.

Further investigation will be needed to suggest a cause for this pattern.

This pattern remains apparent during summer conditions, in exactly the same location, but with a lesser intensity.

Unfortunately, no explanation for the pattern became evident. The interior finish (gypsum board over stud wall cavity) apparently obscures any interior pattern that might help explain why this area leaks more heat than nearby areas. To further investigate the issue, destructive testing would be needed in the highly-secure offices of two different agencies—a practical impossibility under current circumstances.

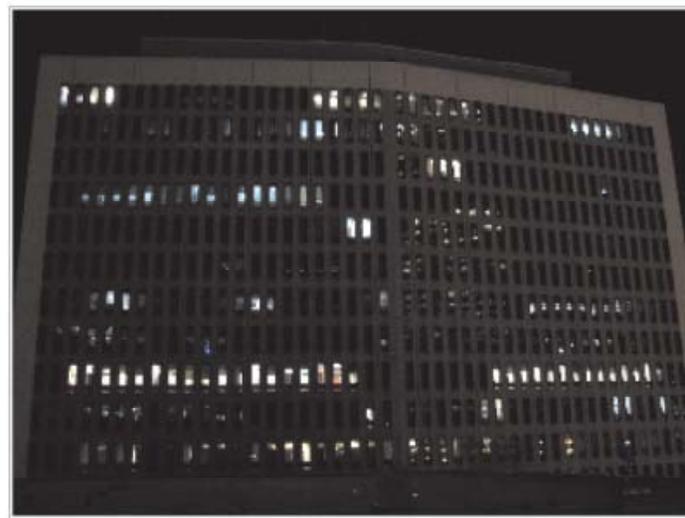
Fig. 21
Federal office building - Location 6
 Taken at night, this image is suggestive of excess moisture accumulation near the joints and tracks which might guide a swing stage used for window cleaning.

Further investigation will be needed to confirm or eliminate moisture as the cause of this pattern.

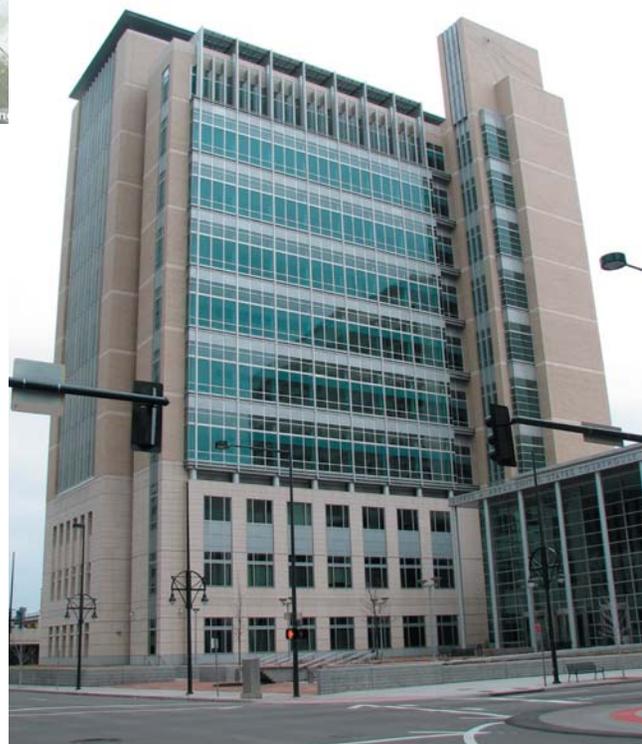
Fig. 23 Arraj Court House - Location 5

The Arraj Court House has had difficulty in achieving the designer's intent of low energy cost. Thermal imaging suggests that one reason may be warm air leakage driven by the intention of maintaining a positive air pressure to avoid cold air infiltration.

Another explanation for the heat leakage may be the fact that considerable air pressure is required from air handlers on the upper floors, in order to push air all the way down to lower floors. Additional air handlers were apparently planned, but were eliminated as a cost-saving measure during construction, leaving the two main air handlers to generate the pressure needed to push air down the building.

Records suggest that 160,000 cfm of outdoor air is sometimes needed to provide sufficient air to all floors—far in excess of ventilation requirements for personnel. This suggests that engineering analysis could find ways to reduce energy consumption in the building.

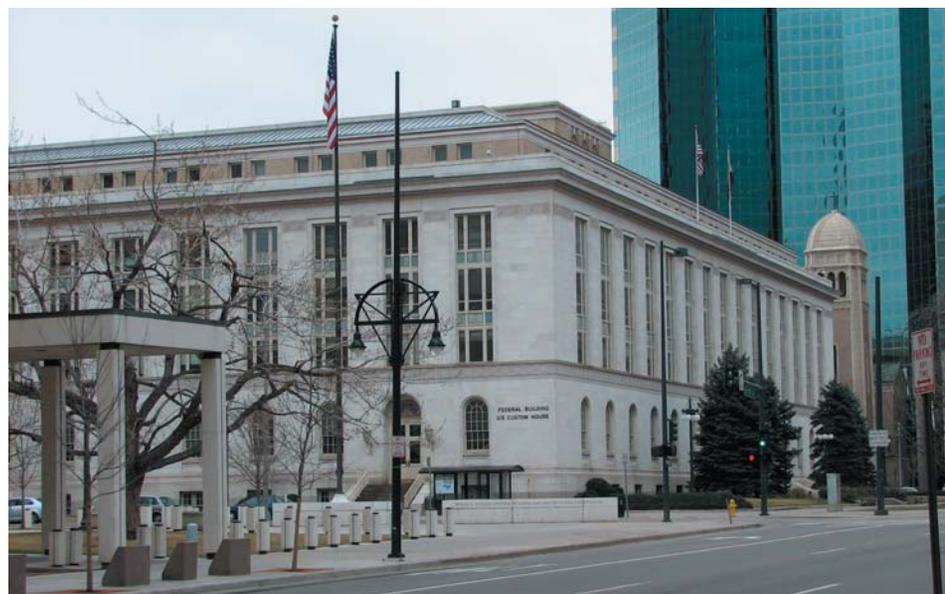
Fig. 29
Customs House - Location 7

The stone facade performs rather well, given it's age and the lack of insulation, showing a surface temperature only 10° above ambient temperature at the hot spot, and a more typical 5° above ambient in other locations, as shown by line 1.

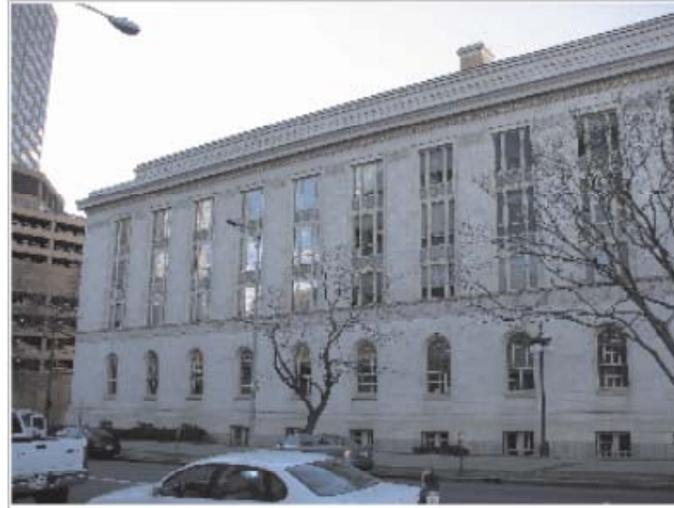
Fig. 31
Customs House - Location 4
The open windows in the third and sixth window bays are quite apparent, based on their much higher temperatures.

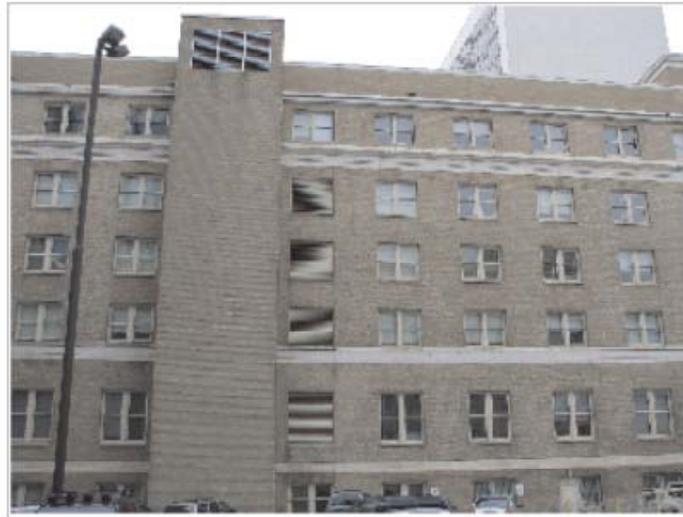
Fig. 32
Customs House - Location C4

The pattern suggests that the heating system is overheating the lower floors in this location.
