**EXTERIOR BUILDING ENVELOPE INSPECTIONS
USING
THERMAL INFRARED IMAGING**

A REPORT TO THE PUBLIC BUILDING SERVICE OF THE GENERAL SERVICES ADMINISTRATION

Contract Number GS-00P-04-CYD-0068

June 30th, 2006

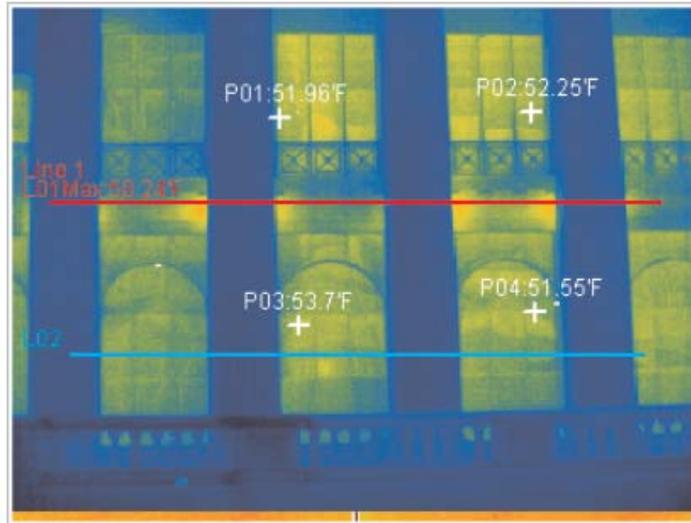
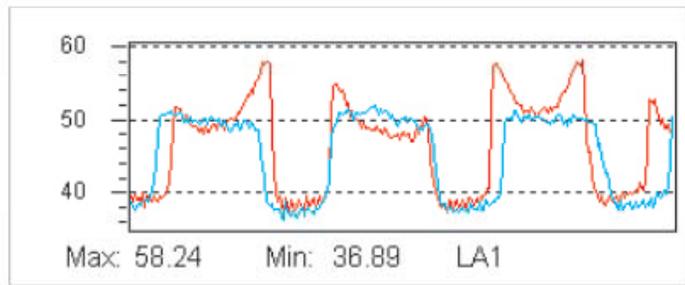
Fig. 5

Byron White - Location 1

Note the warm temperature in the inside corner of the building. This pattern is repeated on all four sides of the building at all outdoor temperatures, suggesting a greater heat loss from these corners than from the balance of the exterior walls.

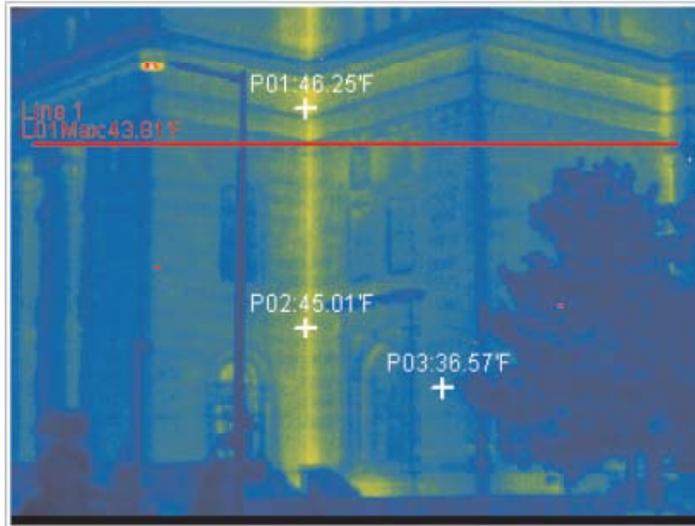
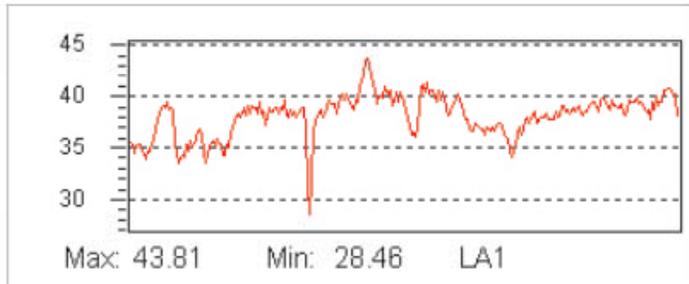
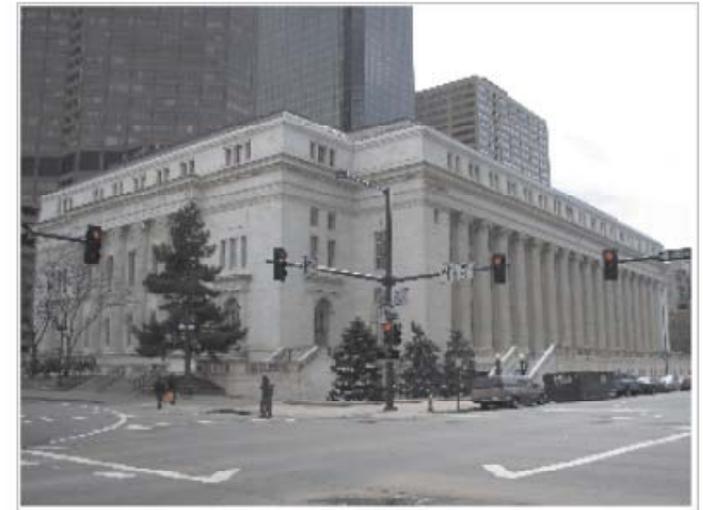
Project Location: Denver Federal District
Building: Byron White Court House (BWCH)
View: Location 7
Weather: Overcast
 32°F db / 16°F dpt
 Light Wind/ NE
Comments:
Thermographer: Bret Monroe

Again note the warm temperature in the inside corner of the building, as seen under warmer outdoor conditions in figure 5.

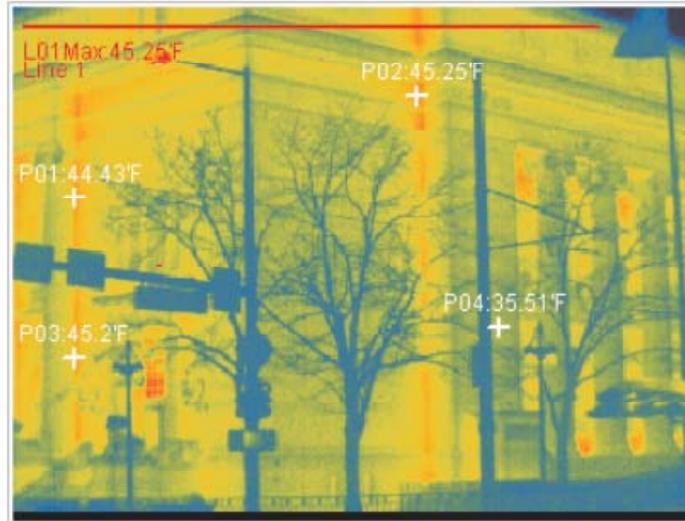
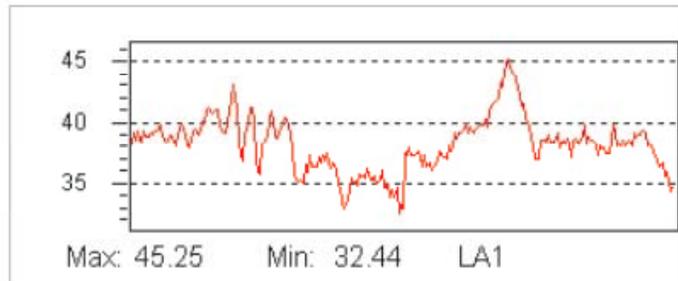
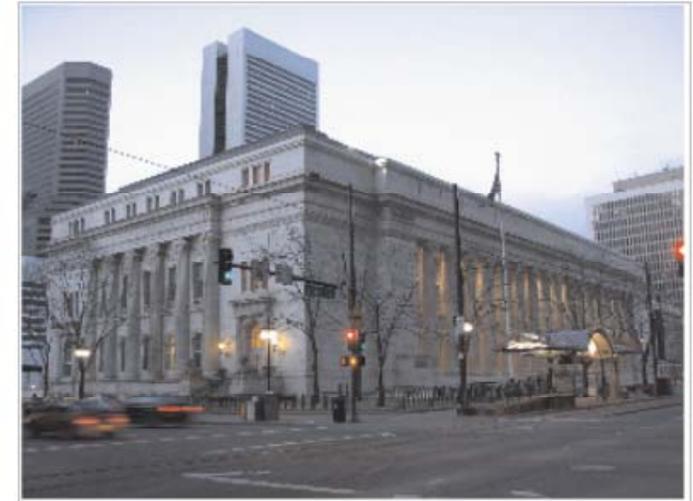
Project Location:	Denver Federal District
Building:	Byron White Court House (BWCH)
View:	Location 5
Weather:	Partly Sunny 34°F db / 15°F dpt Light Wind/ NE
Comments:	
Thermographer:	Bret Monroe

In this case, the visual image does not match the angle of the infrared image because the actual visual image was taken too long before dawn to see clearly. This is the view from location 5.

But the infrared image again shows a consistently high heat loss at the inside corners seen from location 6. The corner temperature is $\pm 45^{\circ}$ when the wall temperature is $\pm 35^{\circ}$ F.

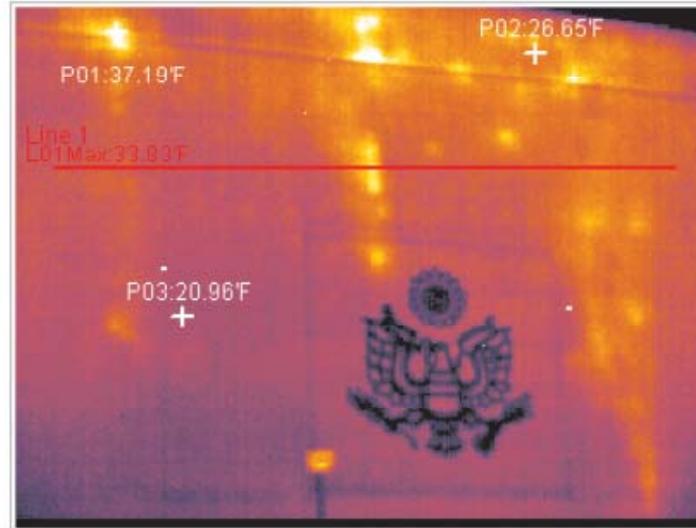
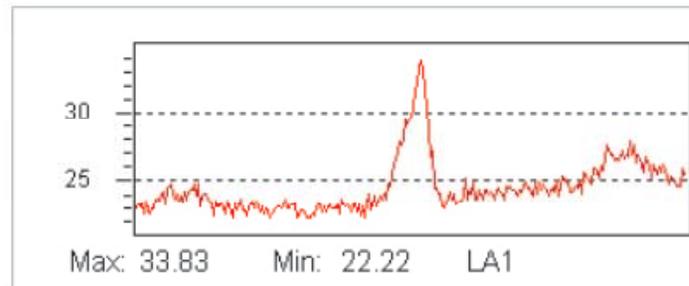
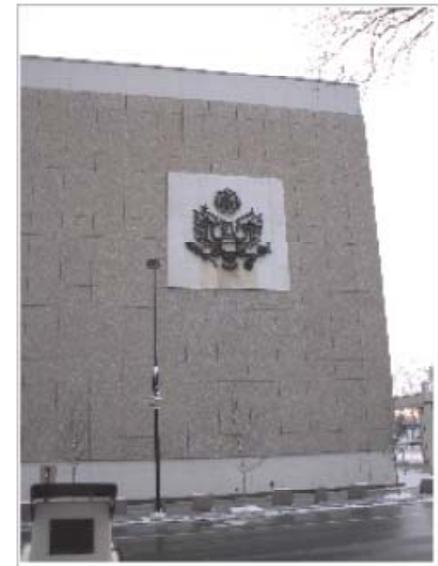
Project Location:	Denver Federal District
Building:	Byron Rogers Court House (BRCH)
View:	Location 6
Weather:	Overcast 26°F db / 22°F dpt Light Wind/ NE
Comments:	
Thermographer:	Bret Monroe

The striking thermal pattern seen in this image has no obvious cause, but is certainly not normal.

Heat is leaking at a greater rate from light areas, which are considerably warmer than the balance of the wall. Note that point one, in a warm area, shows a temperature of 37° which is 17 degrees warmer than was typical at that time for the rest of the walls, as indicated by the reading at point 3.

This pattern was not better-understood after imaging under warm weather conditions. Exterior images taken un June 2006 showed faint traces of these patterns. Unfortunately, in spite of excellent interior access, no internal imaging was possible in this spot, because the interior finish consists of wood paneling. The extra layer formed by the interior paneling made it impossible to gather useful information to explain this pattern from indoors.

This pattern remains an unexplained anomaly.

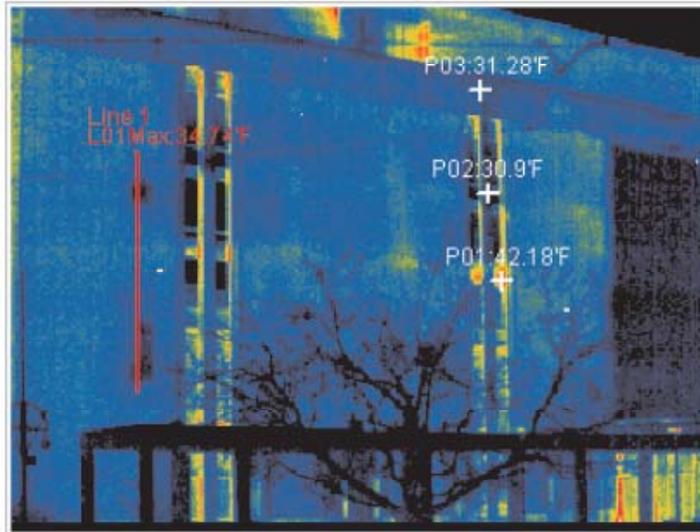
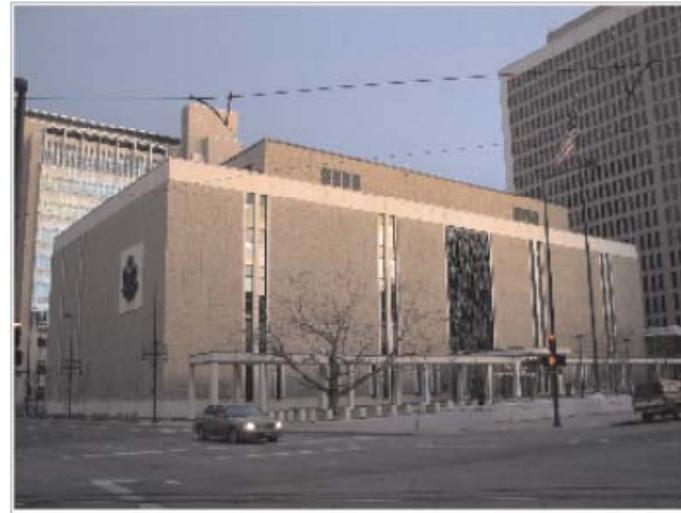
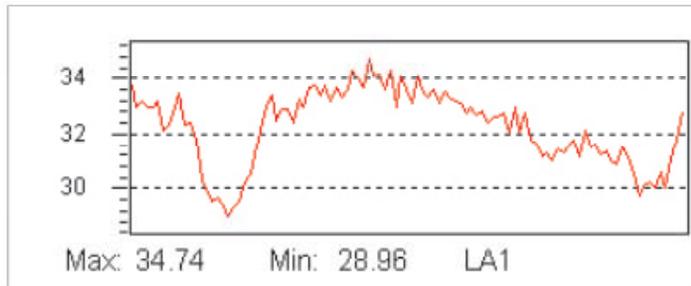
Fig. 12

Heat leaking from the old windows is obvious. But the dark (cool) patterns at the left of the image do not correlate with either panel joints or indoor features known to Jodi Thompson, the renovation project manager.

In the case of this pattern, our inspection in June, performed from the interior, was conclusive. This pattern results from the presence of fire extinguisher boxes set into the wall at locations which correspond exactly to the pattern seen here. Similar patterns are seen in images taken during hot weather conditions.

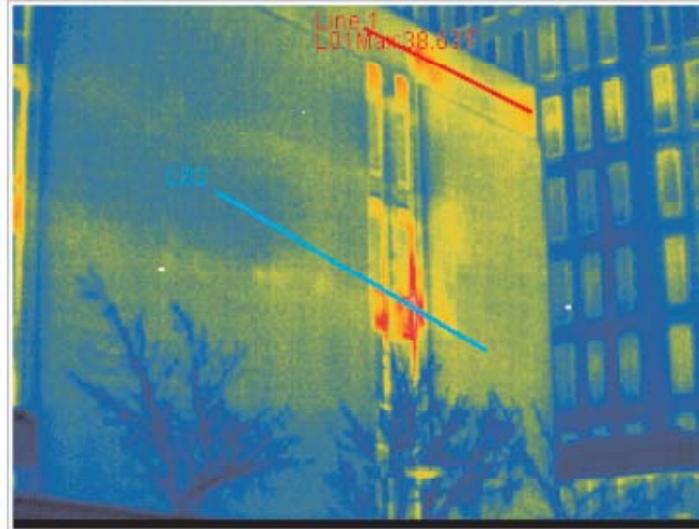
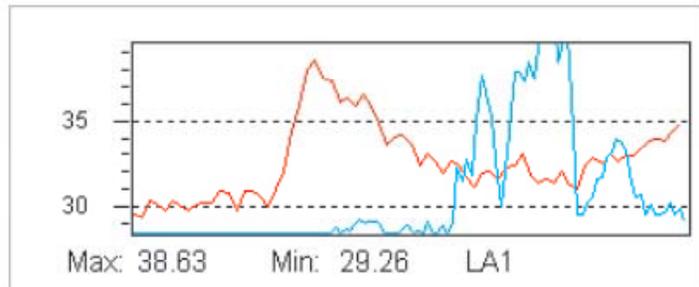
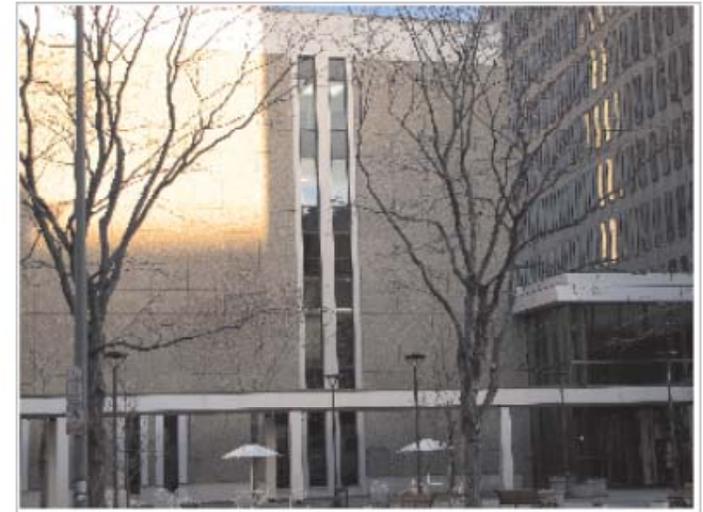
Project Location:	Denver Federal District
Building:	Byron Rogers Court House (BRCH)
View:	Location 4
Weather:	Overcast 26°F db / 22°F dpt Light Wind/ Various
Comments:	
Thermographer:	Bret Monroe

Interior inspection at this location showed that Jodi Thompson's explanation is the most likely cause of the anomaly across line 02. There is indeed a unit heater in that location, and it blows air towards that window, which is covered by a rigid foam insulation panel. That panel was not quite fully pushed into the window cavity, which could and most probably did allow heat to leak out in that location, generating the pattern seen in the winter image.

The pattern seen across line 1 was not explained by any condition visible from indoors, nor was that pattern visible from the exterior during June. That pattern remains unexplained.

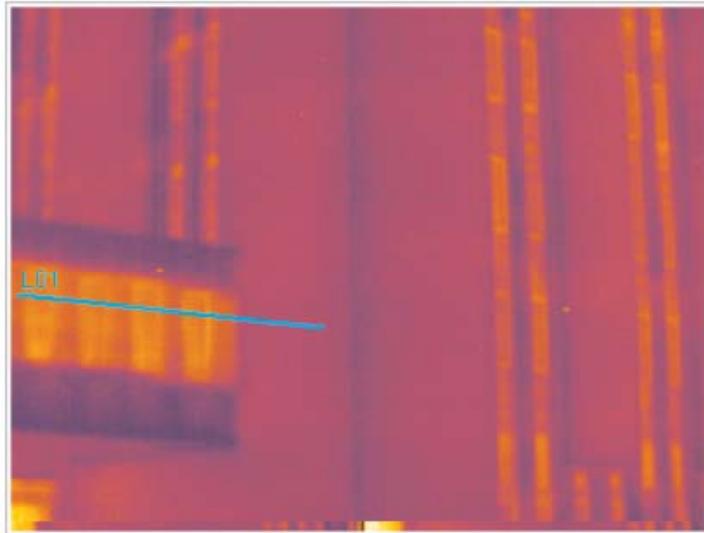
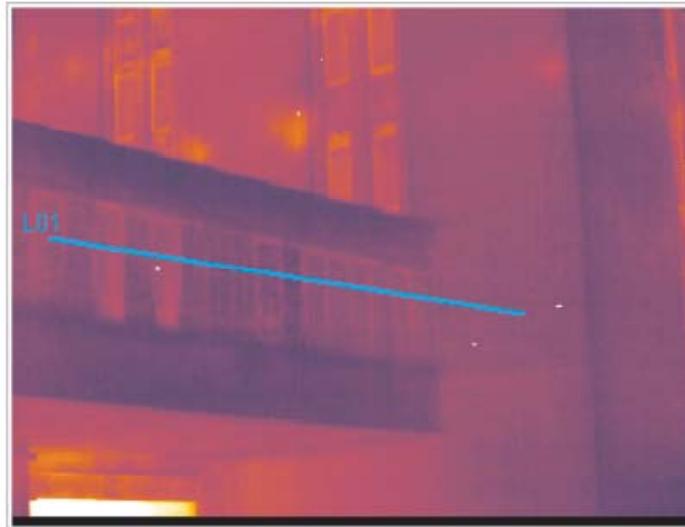
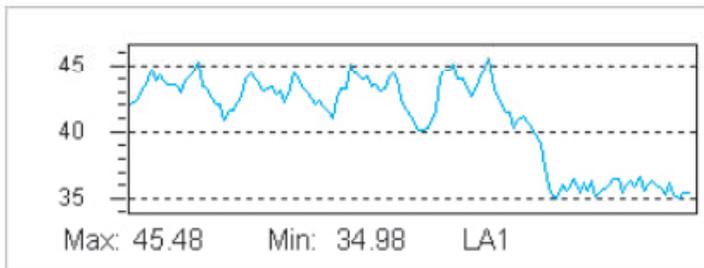
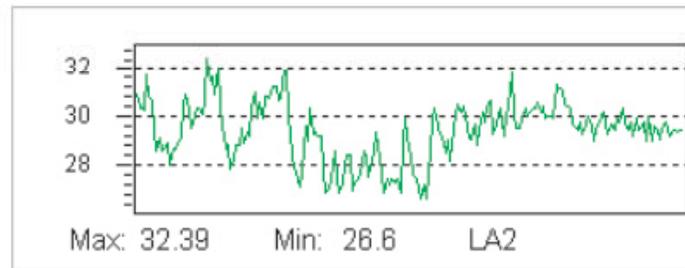
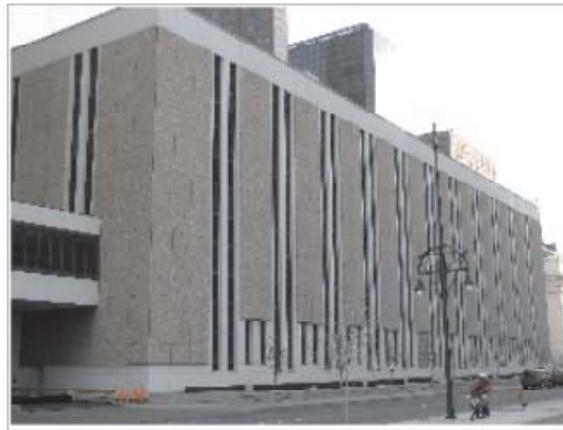
Fig. 14
Byron Rogers - Location 1

The image at left was taken in the afternoon just before the close of the business day, and shows considerable heat loss from the windows of the pedestrian bridge which connects the courthouse to the office building.

The difference between these two thermal images suggests further examination of the HVAC system effects on heat leakage.

This area was not inspected during the June visit. But Joe Baker, GSA contract employee, noted that offices in the courthouse near this location have been notorious for cold air infiltration during the winter. Reportedly, papers can be lifted off of desk by incoming cold air rushing into the bridge area on its way upwards into the adjoining Federal Office Building.

Such a problem would be consistent with the apparent stack-effect air leakage seen in figures 18 and 19. It would also explain why the bridge area leaks heat during the daytime during winter, but less so after the systems are turned off, after the bridge area cools down via air infiltration.

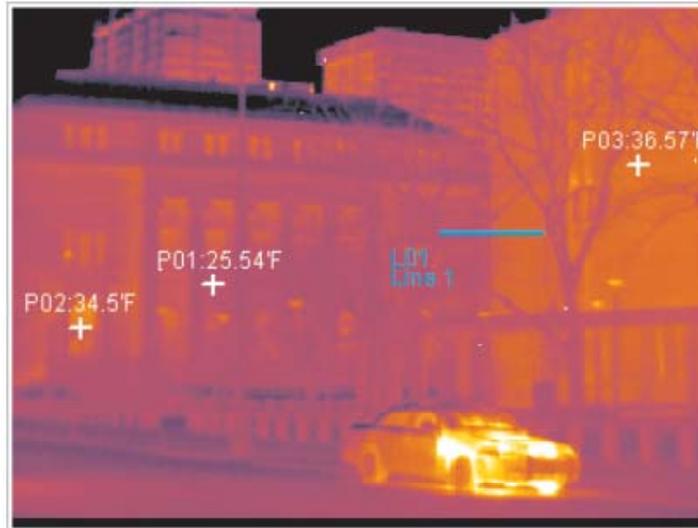
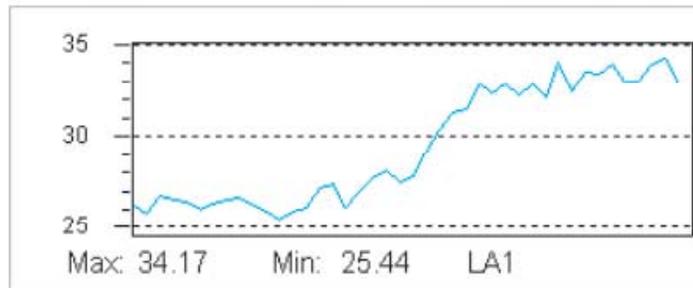
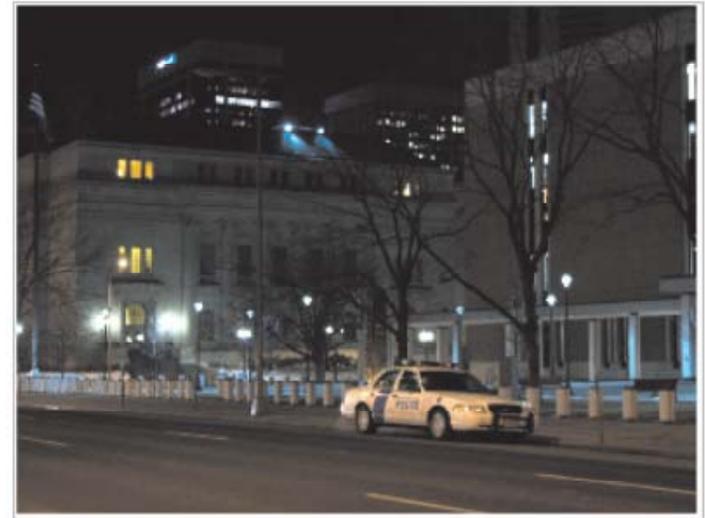
Project Location:	Denver Federal District
Building:	Byron Rogers -vs- Byron White
View:	Location 4
Weather:	Clear 39°F db / 10°F dpt No Wind
Comments:	
Thermographer:	Lew Harriman

This image compares the surface temperatures of the Byron Rogers Court House to those of the neighboring Byron White Court House.

In short, the newer building leaks considerably more heat than the much older building. Compare the temperatures of both buildings by noting the position of line one, and the corresponding temperature graph below the thermal image.

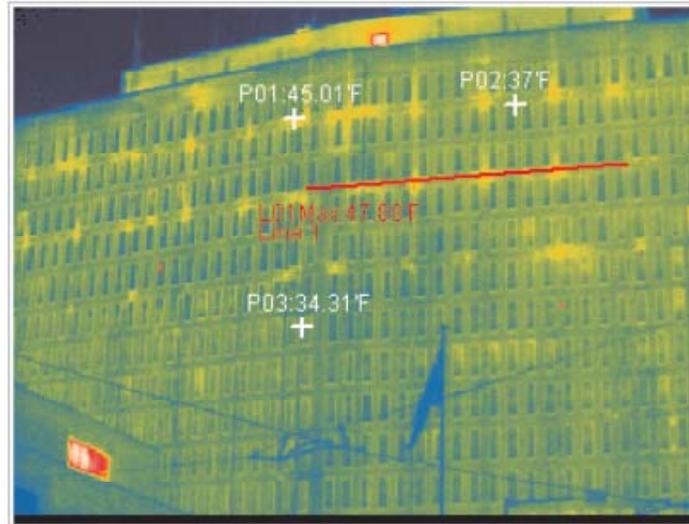
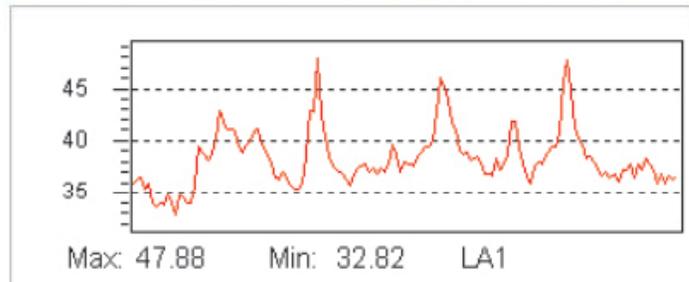
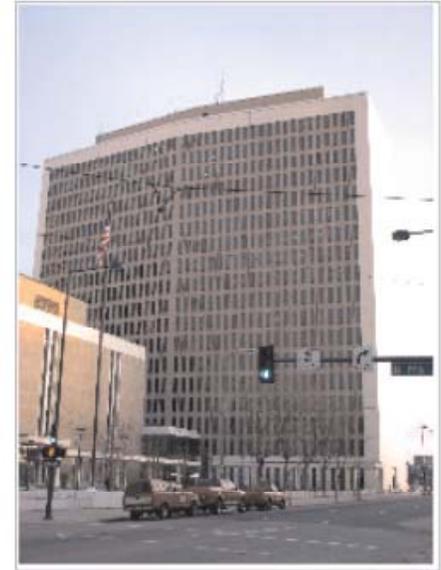
Project Location: Denver Federal District
Building: Federal Office Building (FOB)
View: Location 5
Weather: Clear
 34°F db / 15°F dpt
 Light Wind/ NE
Comments:
Thermographer: Bret Monroe

The pattern shown here is consistent with air leakage due to the stack effect.

In that phenomenon, warm air rises through the building and leaks out through cracks around windows and at panel joints, showing warm spots on the exterior, just as seen in this image.

The temperature indicated at point 1, in one of the warm spots is 45°F, at a time when the outdoor temperature and the temperature of much of the rest of the walls is 34°F as shown at point 3.

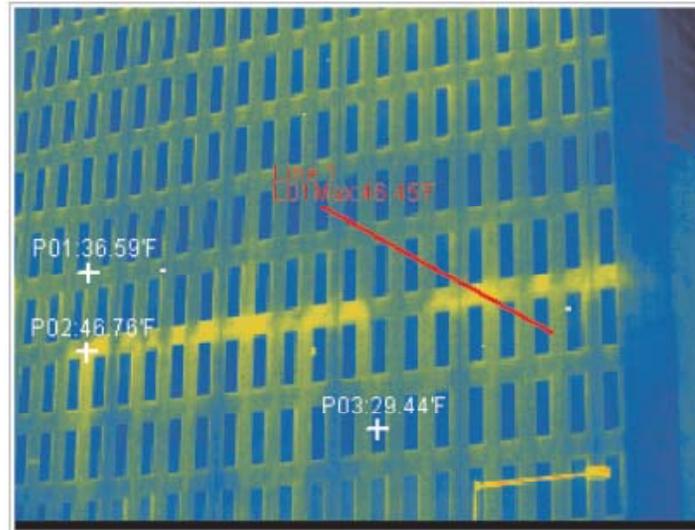
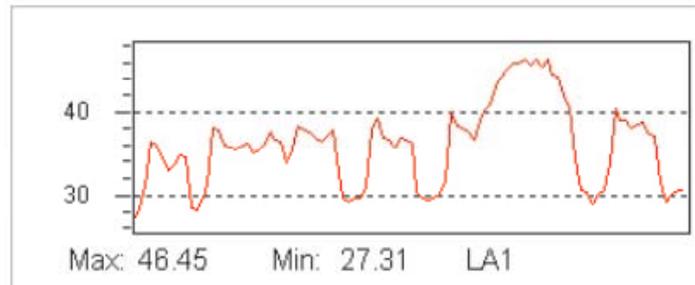
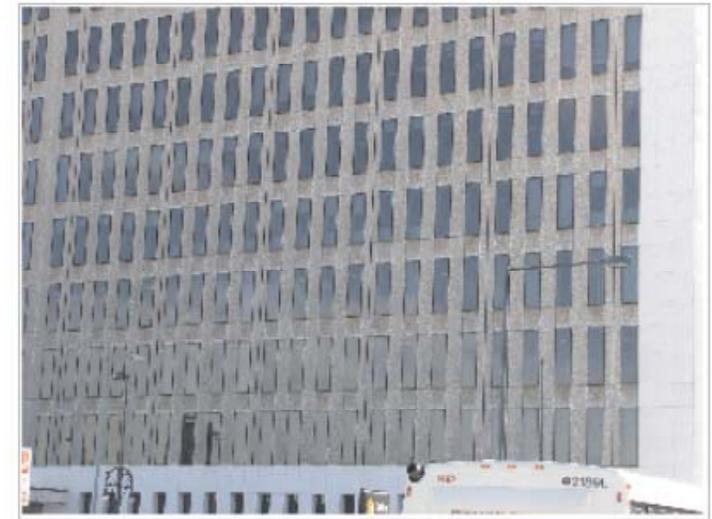
Project Location:	Denver Federal District
Building:	Federal Office Building (FOB)
View:	Location 1
Weather:	Partly Sunny 57°F db / 20°F dpt Light Wind/ NE
Comments:	
Thermographer:	Bret Monroe

In addition to air leakage due to stack effect, on the back side of the building there is a puzzling pattern of warm surface between the 6th and 7th floors, but only at the northern corner.

Further investigation will be needed to suggest a cause for this pattern.

This pattern remains apparent during summer conditions, in exactly the same location, but with a lesser intensity.

Unfortunately, no explanation for the pattern became evident. The interior finish (gypsum board over stud wall cavity) apparently obscures any interior pattern that might help explain why this area leaks more heat than nearby areas. To further investigate the issue, destructive testing would be needed in the highly-secure offices of two different agencies—a practical impossibility under current circumstances.

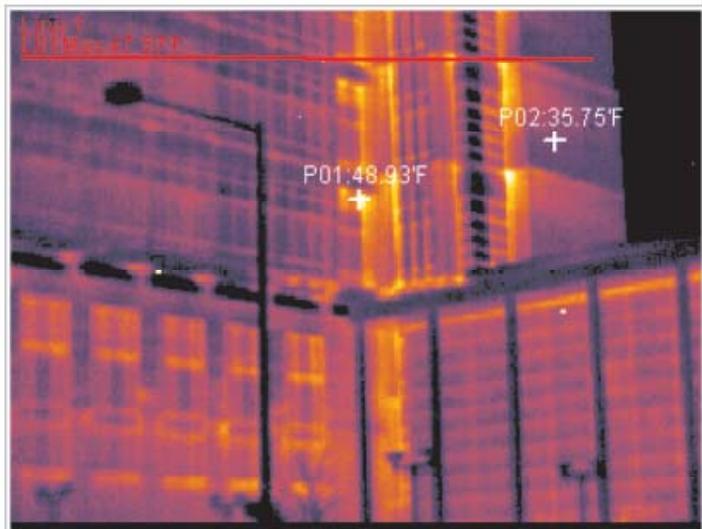
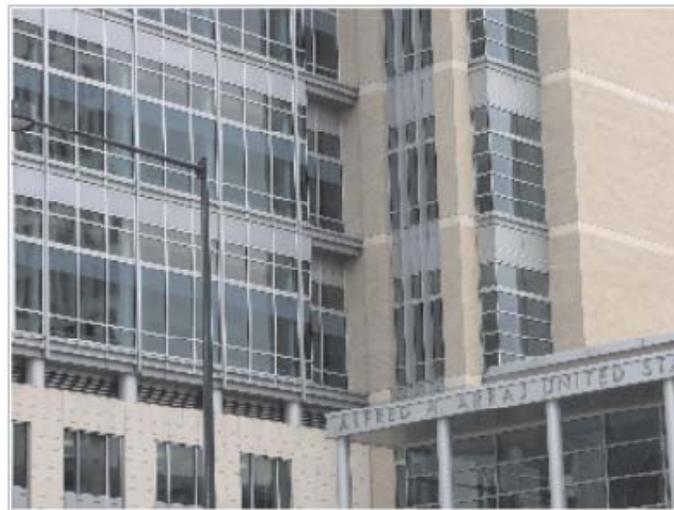
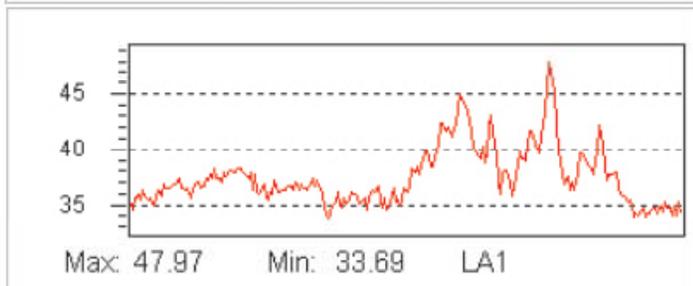
Fig. 24 Arraj - Location 5

A relatively even pattern suggestive of air leakage is consistent all the way up the front facade of the building, unlike the classic stack-effect pattern of more leakage at the top of the building.

Also, the heat leakage from the tower at the right of the curtain wall is notable, showing temperatures above 46° when other wall temperatures remain near the outdoor air temperature of 32°F.

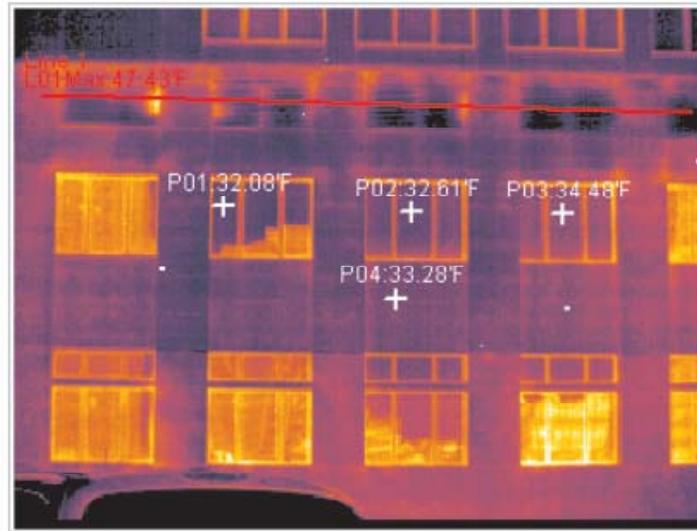
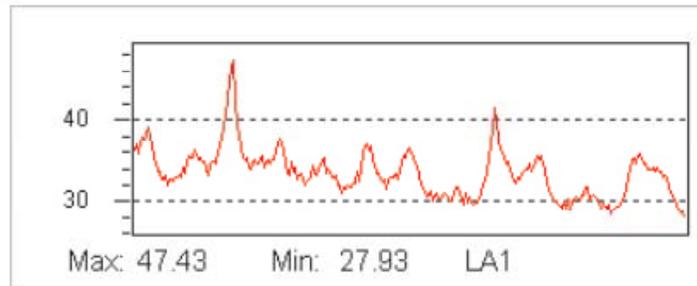
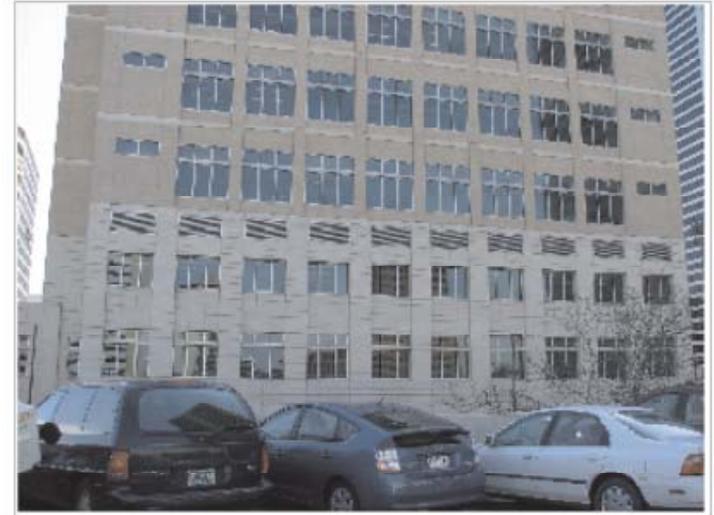
On the other hand, it's not clear why the temperatures of the wall above and around the air intake louvers shown under line 1 are so high. The pattern suggests outward warm air leakage at the very point where one would instead expect a slight inward drift of cold air caused by the suction of the ventilation fans.

Air leakage seems consistent with these winter images, and with building automation records discussed during the June visit.

These patterns probably have several different causes, which suggests that detailed engineering analysis would be fruitful, especially in light of the large amount of outdoor air apparently used to generate adequate pressure to reach all parts of the building (160,000 cfm).

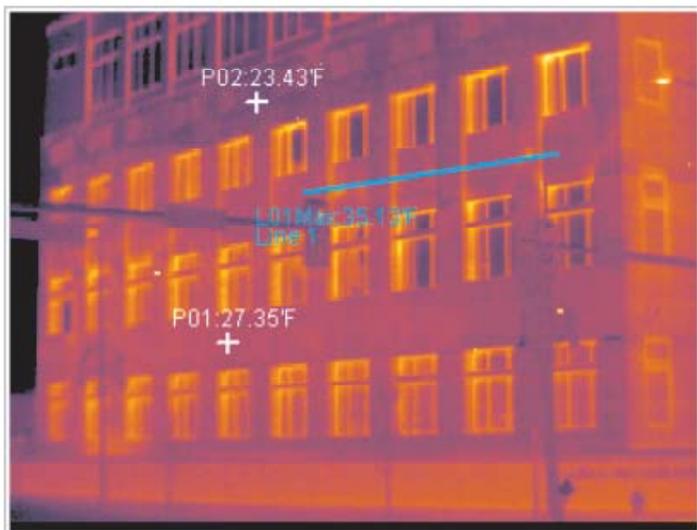
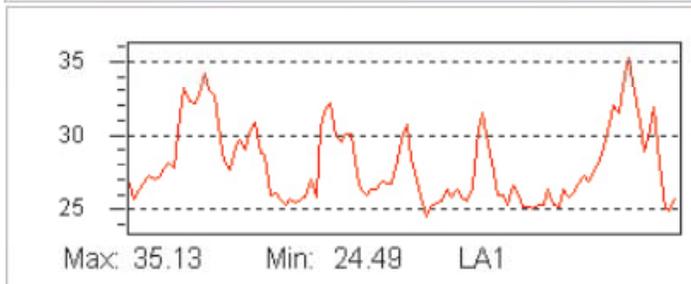
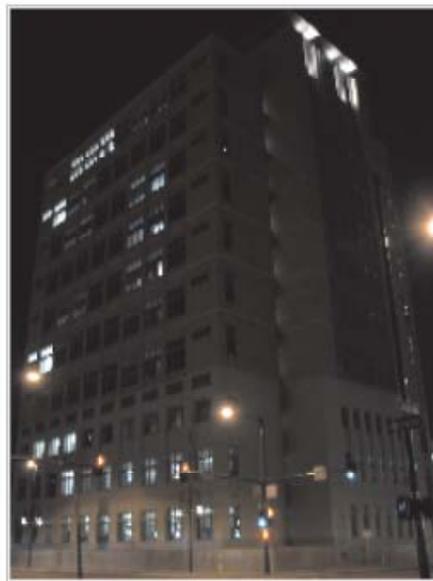
Fig. 26

Just as in the images shown in figure 24, this pattern partly repeats during the warm months, in an odd way. Heat appears to be leaking out at the floor-dividing bands. One would expect these to be colder during summer months if they leak heat in the winter.

Some of these patterns could be explained by different materials, with different heat capacity rates, which lag the thermal changes after dawn and after sundown. But air leakage also seems consistent with the winter images, and with building automation records provided during the June visit. These patterns probably have several different causes, which suggests that detailed engineering analysis would be fruitful.

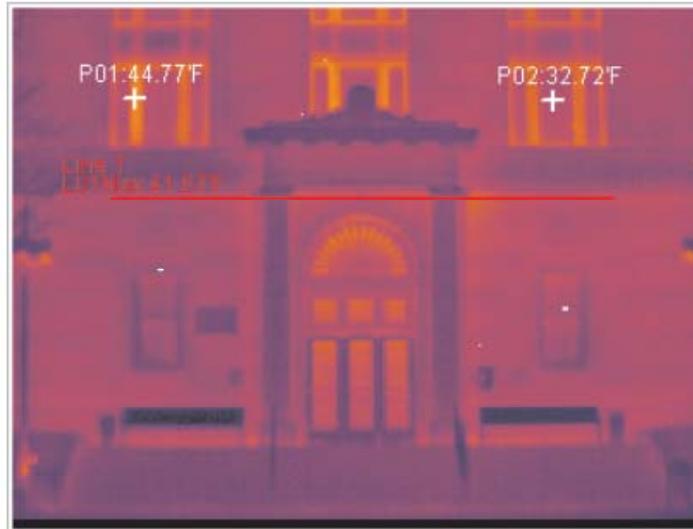
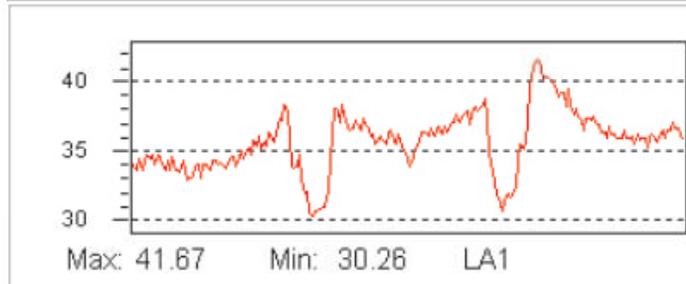
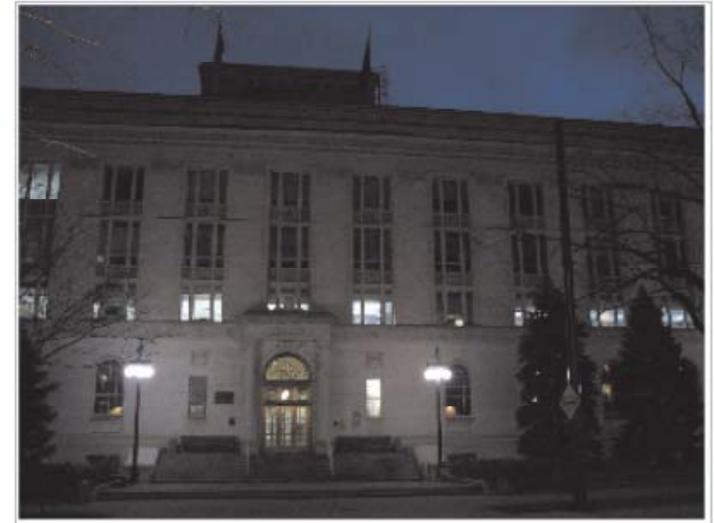
Fig. 30
Customs House - Location 6

The window frames are showing heat leakage rates greater than the windows, as one would expect for metal frames without thermal breaks. Point 1, on the frame, shows 44° while the glass surface suggests a temperature of 32°F, very near the current air temperature.

The stone facade performs rather well, given it's age and the lack of insulation, showing a surface temperature only 10° above ambient temperature at the hot spot, and a more typical 5° above ambient in other locations, as shown by line 1.

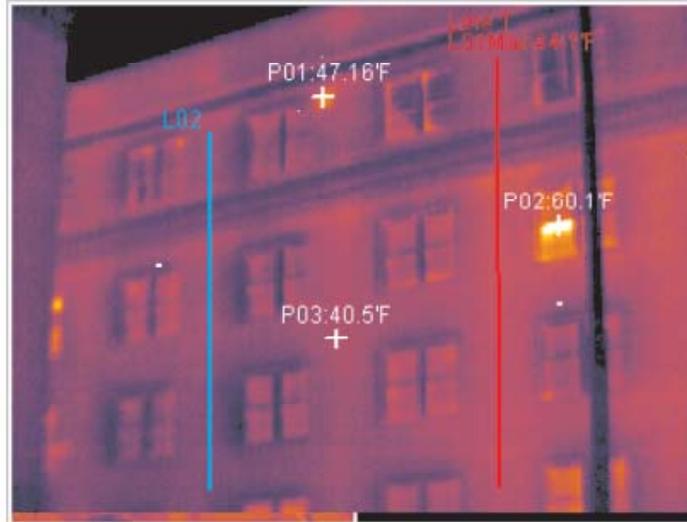
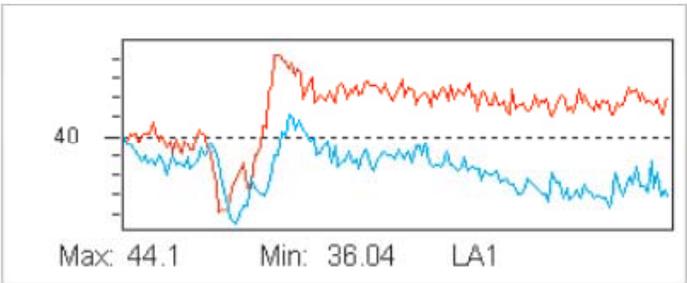
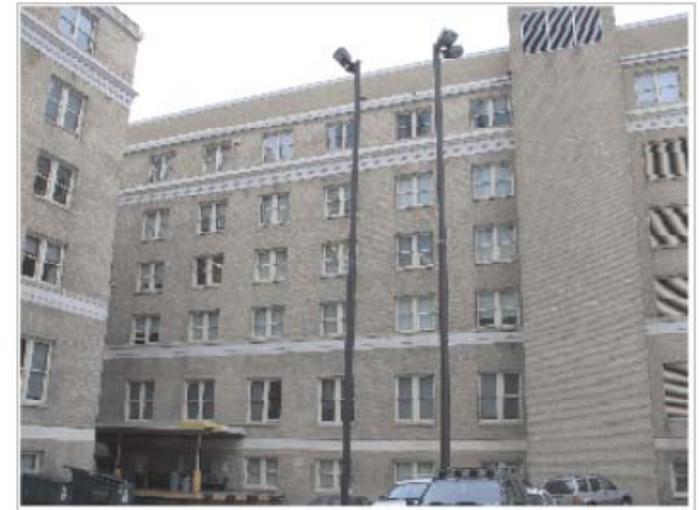
Project Location:	Denver Federal District
Building:	Customs House
View:	Location- Courtyard 4
Weather:	Overcast 36°F db / 16°F dpt No Wind
Comments:	
Thermographer:	Lew Harriman

The brick facade in the courtyard shows more heat leakage at the lower stories than at the top—the reverse of what one would expect with stack effect air leaks.

The pattern suggests that the heating system is overheating the lower floors in this location.

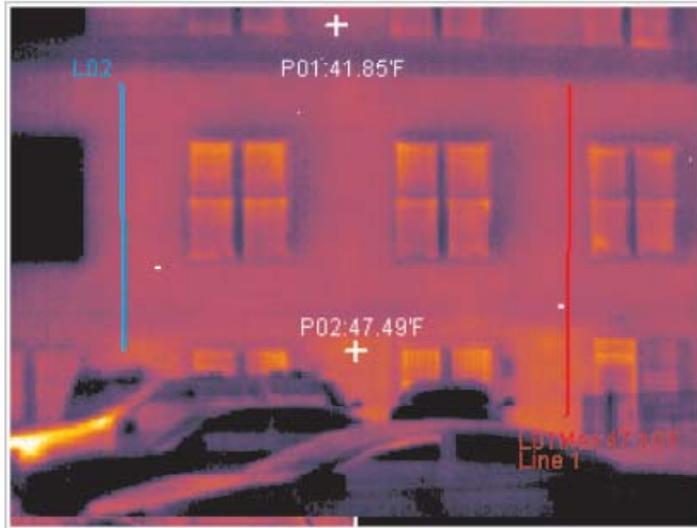
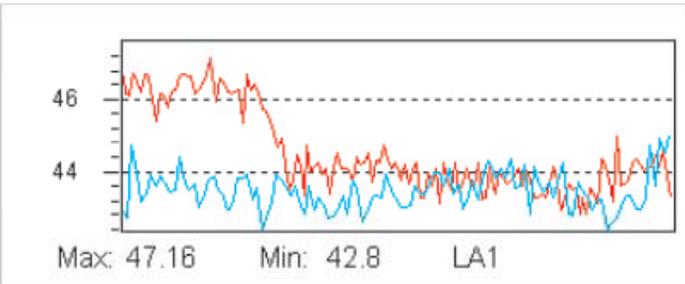
Project Location:	Denver Federal District
Building:	Customs House
View:	Location- Courtyard 4b
Weather:	Overcast 36°F db / 16°F dpt No Wind
Comments:	
Thermographer:	Lew Harriman

Hot spots are also found when moving horizontally across the brick surface. Note the cooler temperatures across line one compared to line two, and the 48° temperature shown at point 2 compared to the 42° temperature at point 1.

The basement level in this section of the building appears to be leaking more heat than other locations, suggesting that the heating system is overheating the basement.
