November 2003 • Vol. 40 No. 11

Moisture

Using Surface

By Lew Harriman

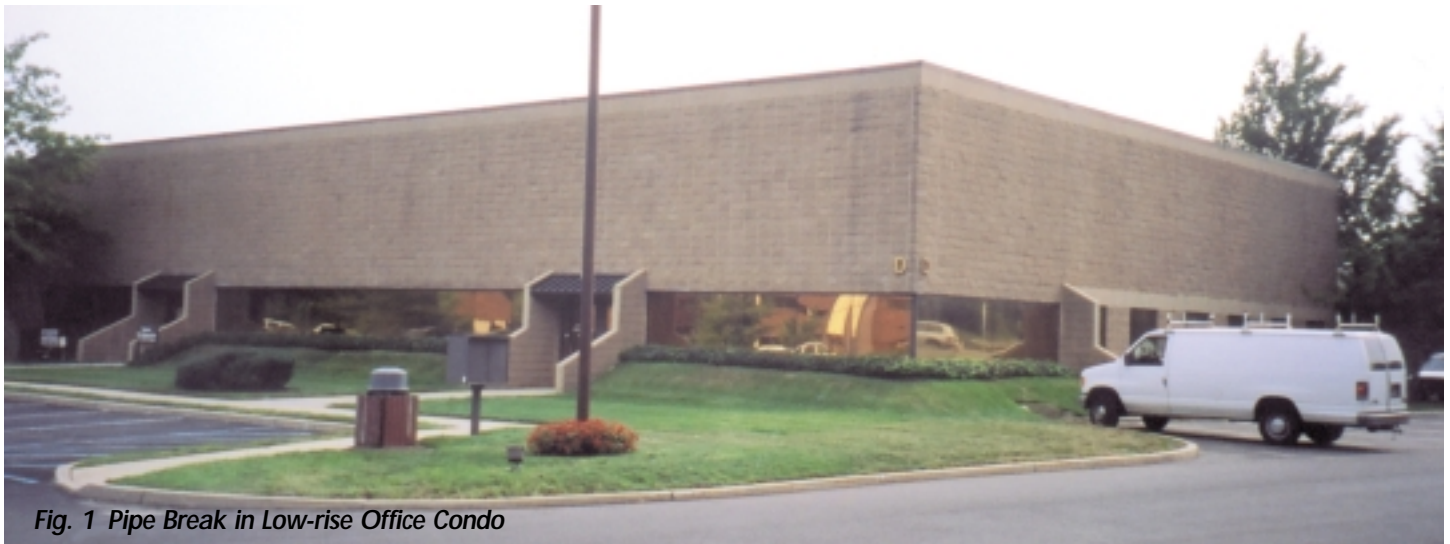
Fig. 1 Pipe Break in Low-rise Office Condo

A small water heater pipe break soaked about 7800 square feet over a weekend. Water seeped up walls through capillary action.

Thanks to Jesse Allen, Tom Rupp and Spencer Hess of Commercial Drying Technologies, and Allan Goeltz and Tim Jarema of Insurance Restoration Specialists, who generously provided the opportunity for the photos shown in figures 1 through 7.

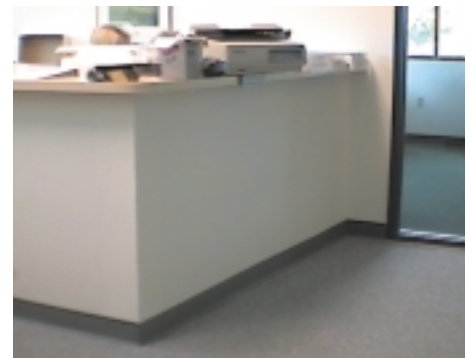
Fig. 2 Workstation

Water evaporating from the gypsum board slightly lowers the surface temperature, a pattern that is obvious when viewed through a high-resolution infrared video camera.

1. **Evaporation.** Moisture cools the surface as it evaporates, so that moist areas appear cooler than dry areas. Figures 2 through 6 show this effect clearly. Water that soaked the carpet also wicked-up through the gypsum board walls. As that water evaporates, it pulls heat from the wall, creating a darker pattern in the moist areas.

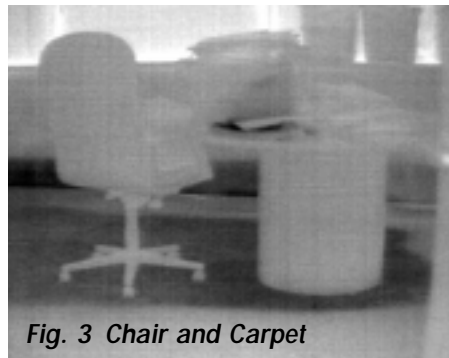
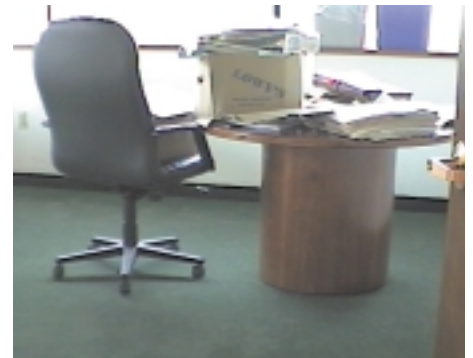
Fig. 3 Chair and Carpet

The thermal pattern clearly indicates that moisture remains in part of the carpet and in the lower portion of the wall

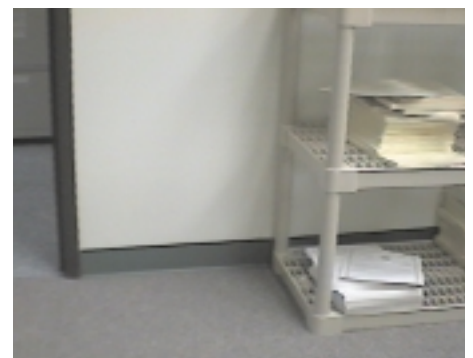
Fig. 4 Shelf & Wall

The visual image shows no indication of water damage. But the high-resolution infrared image allows the inspector to quickly identify suspect areas.

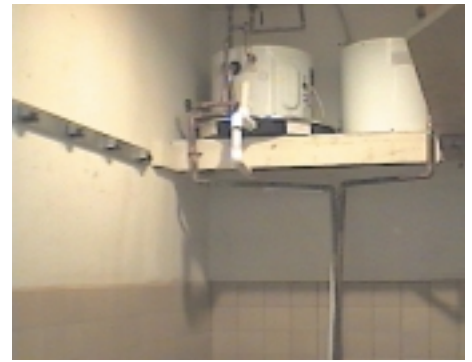
Fig. 5 Water Heater

This new heater replaced the one that broke and soaked the building. This pair of images shows that layers in a wall can hide the thermal patterns that indicate moisture. Moisture does not cool the tile surface low enough to create a thermal pattern.

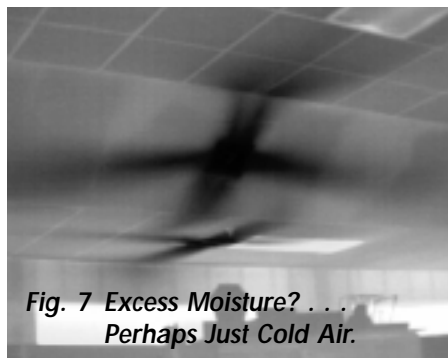
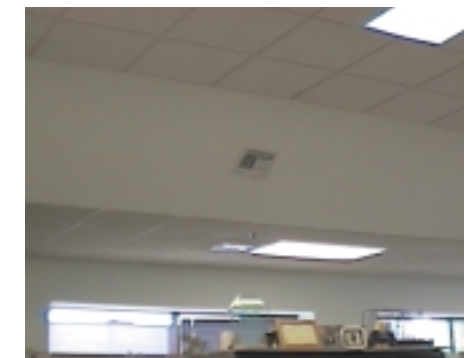
Fig. 7 Excess Moisture? . . . Perhaps Just Cold Air.

It's essential to confirm the presence of moisture with moisture meter readings. Not all thermal patterns indicate a moisture problem. Cold air from the air conditioning system creates thermal patterns that can look like excess moisture.

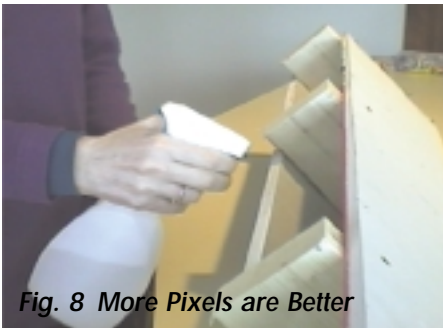
Fig. 8 More Pixels are Better

In many situations, the thermal patterns generated by moisture are not very obvious. Generally, the higher the resolution of the camera, the easier it is to locate moisture.

With many pixels, you can see patterns that are nearly invisible to cameras with fewer pixels. The photos in figure 8 show why you'd prefer to be using the camera with the larger number of pixels.
